Toitū Te Hākapupu project Culvert replacement for fish passage improvement, Watkin River

Cargill Contracting Ltd (CCL) assists the Otago Regional Council (ORC) with culvert replacement for fish passage improvement.

Client	OTAGO REGIONAL COUNCIL
Project	CULVERT REPLACEMENT FOR FISH PASSAGE IMPROVEMENT
Location	WATKIN RIVER, EAST OTAGO
Expertise	STREAM RESTORATION, CULVERT INSTALLATION, FISH PASSAGE COMPLIANCE

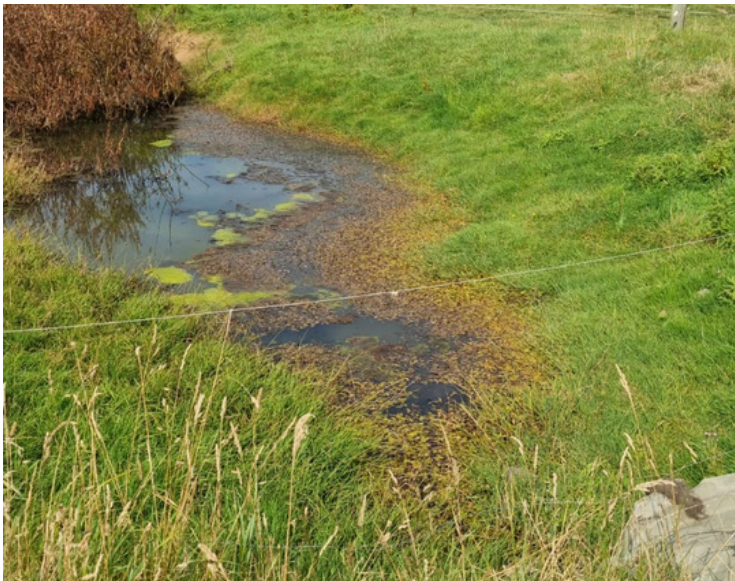
At the W1 and W2 sites in the Watkin River catchment, the existing farm culverts are perched above the stream, with significant overhangs and internal structures that restrict fish movement. This not only impacts the culturally and ecologically significant inanga (*Galaxias maculatus*), but also other native migratory species such as koaro (*Galaxias brevipinnis*), banded kōkopu (*Galaxias fasciatus*), and giant kōkopu (*Galaxias argenteus*), all of which rely on **unobstructed fish passage** to access critical upstream habitats. Resident species like the common river galaxias (*Galaxias vulgaris*) also face challenges due to these barriers.

Pre-project site visit of the Watkin River catchment (W1),
Photo: © Cargill Contracting Ltd 2025, used with permission.

At both sites (W1 and W2), CCL removed the existing perched culverts and replaced them with structures compliant with the New Zealand Fish Passage Guidelines. The design replicated natural stream conditions to allow fish passage at all life stages.

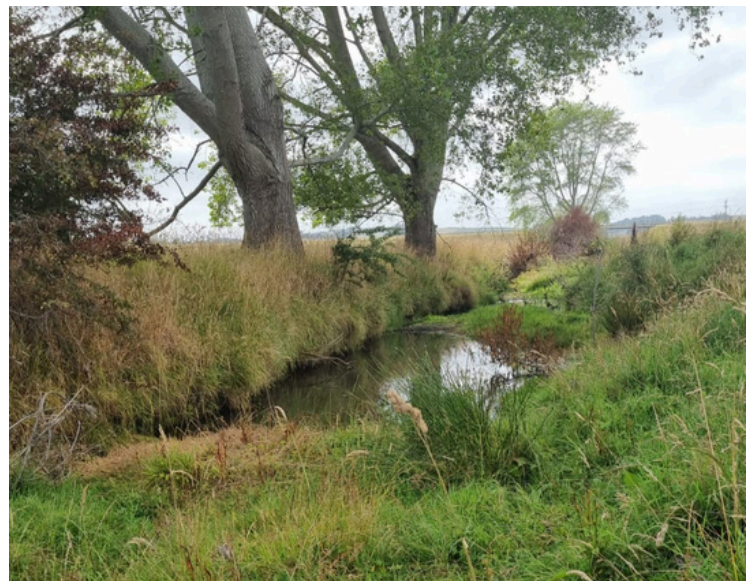
Pre-project site visit of the Watkin River catchment (W2),
Photo: © Cargill Contracting Ltd 2025, used with permission.

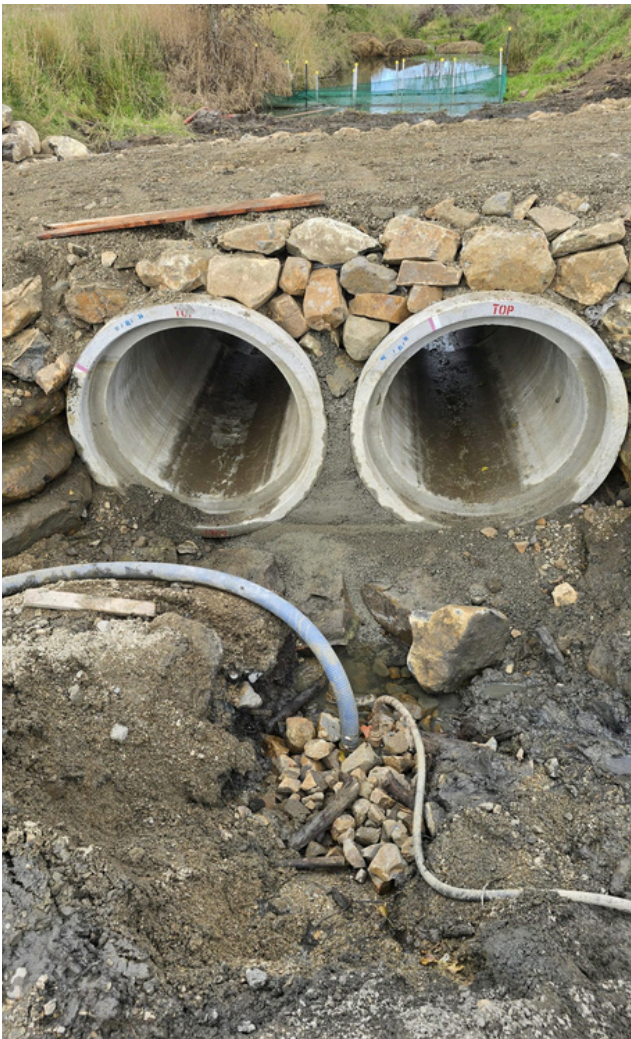
Installation of a twin 1200mm culvert with compacted rock bedding to support fish passage and resilient flood flow on the Watkin River, April 2025.

- Twin-pipe system (W1 site) and single 1800 culvert (W2 site) installed to support fish migration during dry period
- Culverts installed 30–50% below the streambed to mimic natural channel form
- All pipes placed at the same 0% gradient as the streambed, suitable for fish passage while protecting the overlying Goodwood Scheme pipeline (W2 site).
- Culverts kept within ORC's recommended 6m length to maintain hydraulic performance
- Temporary 2mm fish screens protected species during construction and removed only once sediment risks subsided
- Instream baffles and embedded substrate added to reduce water velocity and improve accessibility for native fish species

- Durability and performance were key to the culverts' long-term success. Materials and construction methods were chosen for structural integrity, erosion control, and adaptability to high-flow conditions.
- Compact AP20 bedding and AP150 fill provided strength and compaction
- Rock armouring on 2:1 slopes extended beyond culvert ends to protect against scour
- Rock headwall constructed to prevent undercutting and resist hydraulic forces

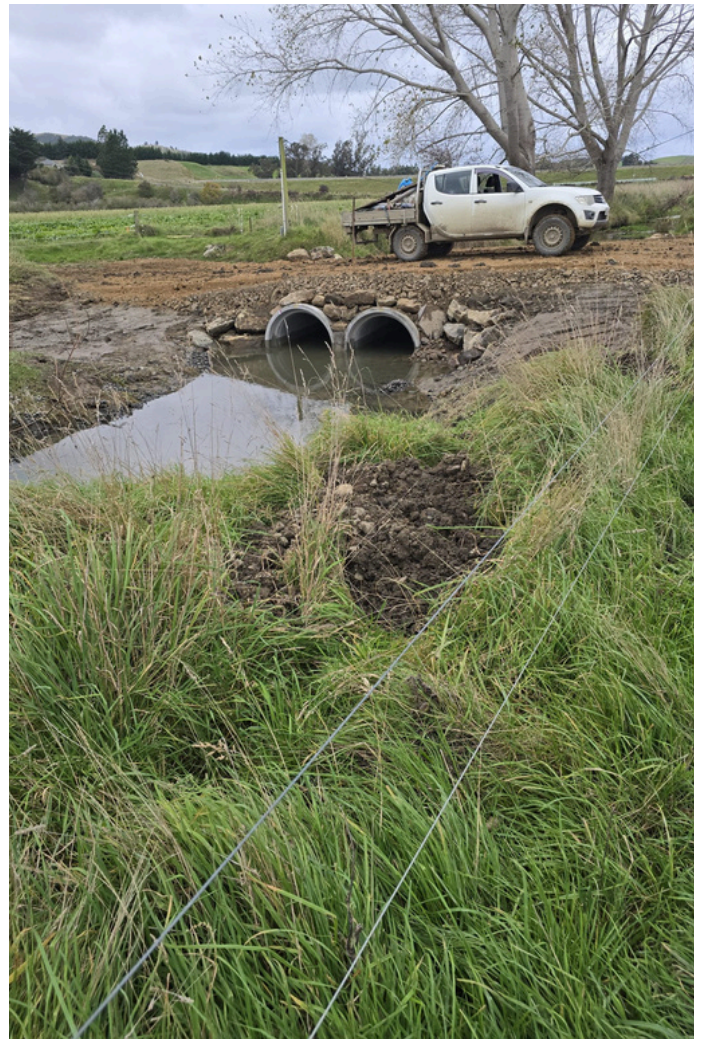
Twin 1200mm culvert installed at Watkin River, April 2025. This structure was delivered by Cargill Contracting Ltd for the Otago Regional Council.
