# Toitū Te Hākapupu project Culvert replacement for fish passage improvement, Pleasant River

Cargill Contracting Ltd (CCL) assists the Otago Regional Council (ORC) with culvert replacement for fish passage improvement.

Client	OTAGO REGIONAL COUNCIL
Project	CULVERT REPLACEMENT FOR FISH PASSAGE IMPROVEMENT
Location	PLEASANT RIVER, EAST OTAGO
Expertise	STREAM RESTORATION, CULVERT INSTALLATION, FISH PASSAGE COMPLIANCE

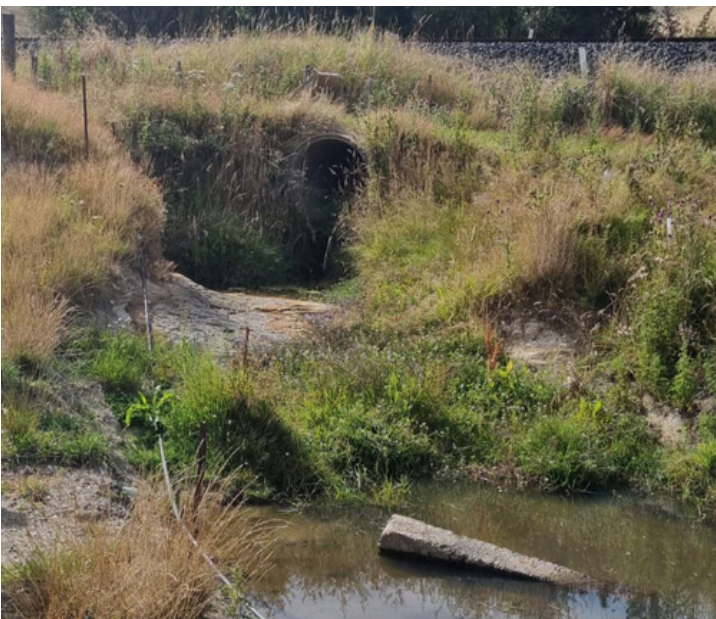
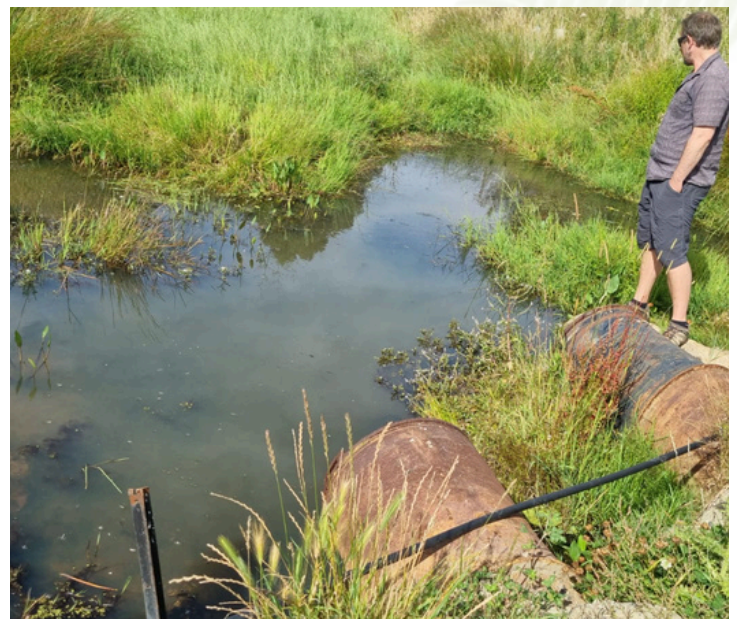
At the H6 site in the Pleasant River catchment, the existing culvert is perched above the stream, with significant overhangs and internal structures that restrict fish movement. This not only impacts the culturally and ecologically significant inanga (*Galaxias maculatus*), but also other native migratory species such as koaro (*Galaxias brevipinnis*), banded kōkopu (*Galaxias fasciatus*), and giant kōkopu (*Galaxias argenteus*), all of which rely on **unobstructed fish passage** to access critical upstream habitats. Resident species like the common river galaxias (*Galaxias vulgaris*) also face challenges due to these barriers.

Pre-construction site assessment of perched culvert in the Pleasant River catchment.

This structure posed a barrier to native fish migration and was identified for replacement as part of the Toitū Te Hākapupu restoration programme.

- Culvert installed 30–50% below the streambed to mimic natural channel form
- Boulder placed downstream to redirect high flows and create a calmer bypass channel
- Culvert kept within ORC's recommended 6m length to maintain hydraulic performance
- Temporary 2mm fish screens protected species during construction and were removed only once sediment risks subsided
- Compliant with NZ Fish Passage Guidelines, NES-FW, and Otago Regional Plan: Water for Otago

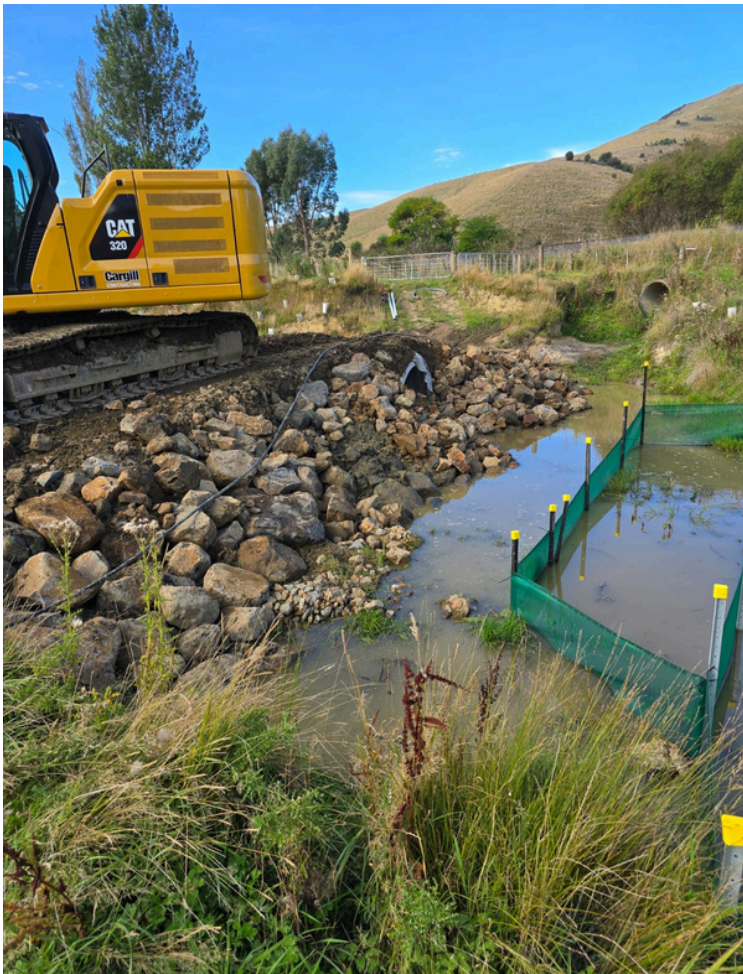
Site preparation underway at Pleasant River for culvert installation. CCL initiates streambed stabilisation with rock armouring and sediment controls to allow a compliant, fish-friendly crossing under the Toitū Te Hākapupu programme.

- Use of locally sourced rock from Evansdale Quarry minimised transport emissions
- Construction respected cultural and ecological values from prior iwi collaborations
- Comprehensive sediment controls (silt fences, hay bales, coir logs, silt curtains) protected water quality
- Oversight by ORC fish passage expert and CCL's Environmental Compliance Officer ensured best practice delivery

- Durability and performance were key to the culvert's long-term success. Materials and construction methods were chosen for structural integrity, erosion control, and adaptability to high-flow conditions.
- Compact AP20 bedding and AP150 fill provided strength and compaction
- Rock armouring on 2:1 slopes extended beyond culvert ends to protect against scour
- Rock headwall constructed to prevent undercutting and resist hydraulic forces

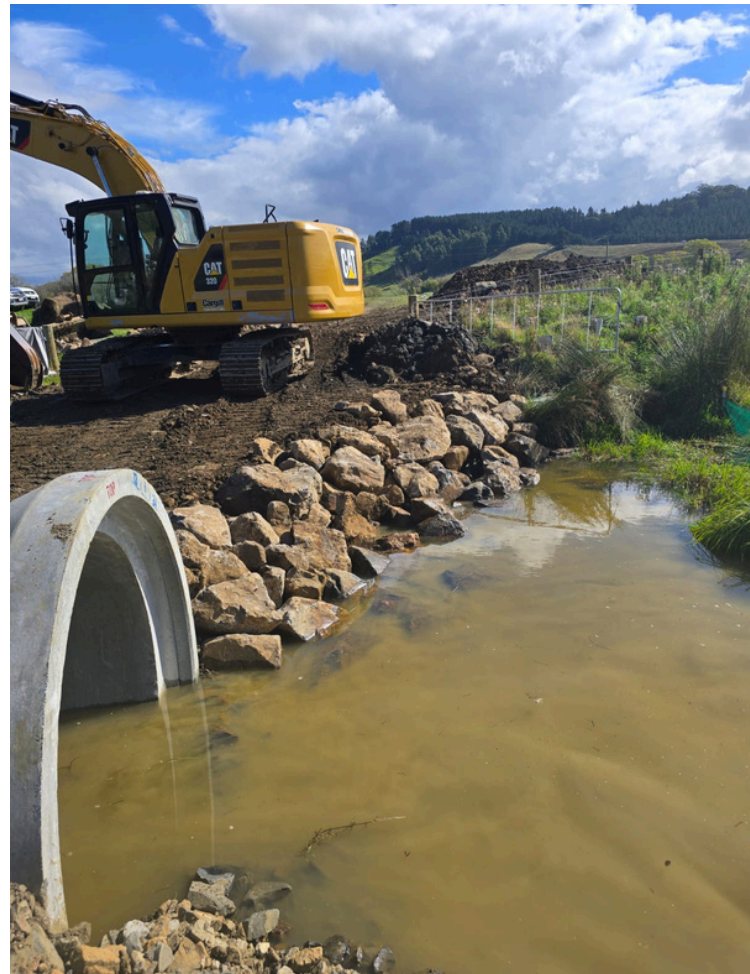
Fish passage-compliant culvert installed below streambed at Pleasant River. CCL embedded the structure within natural channel form to support native fish migration, in line with national freshwater regulations and ORC guidelines.
